# National Inspection Services

Report: 340258  
08/19/2026

## 2010 INTERNATIONAL PROSTAR LF627

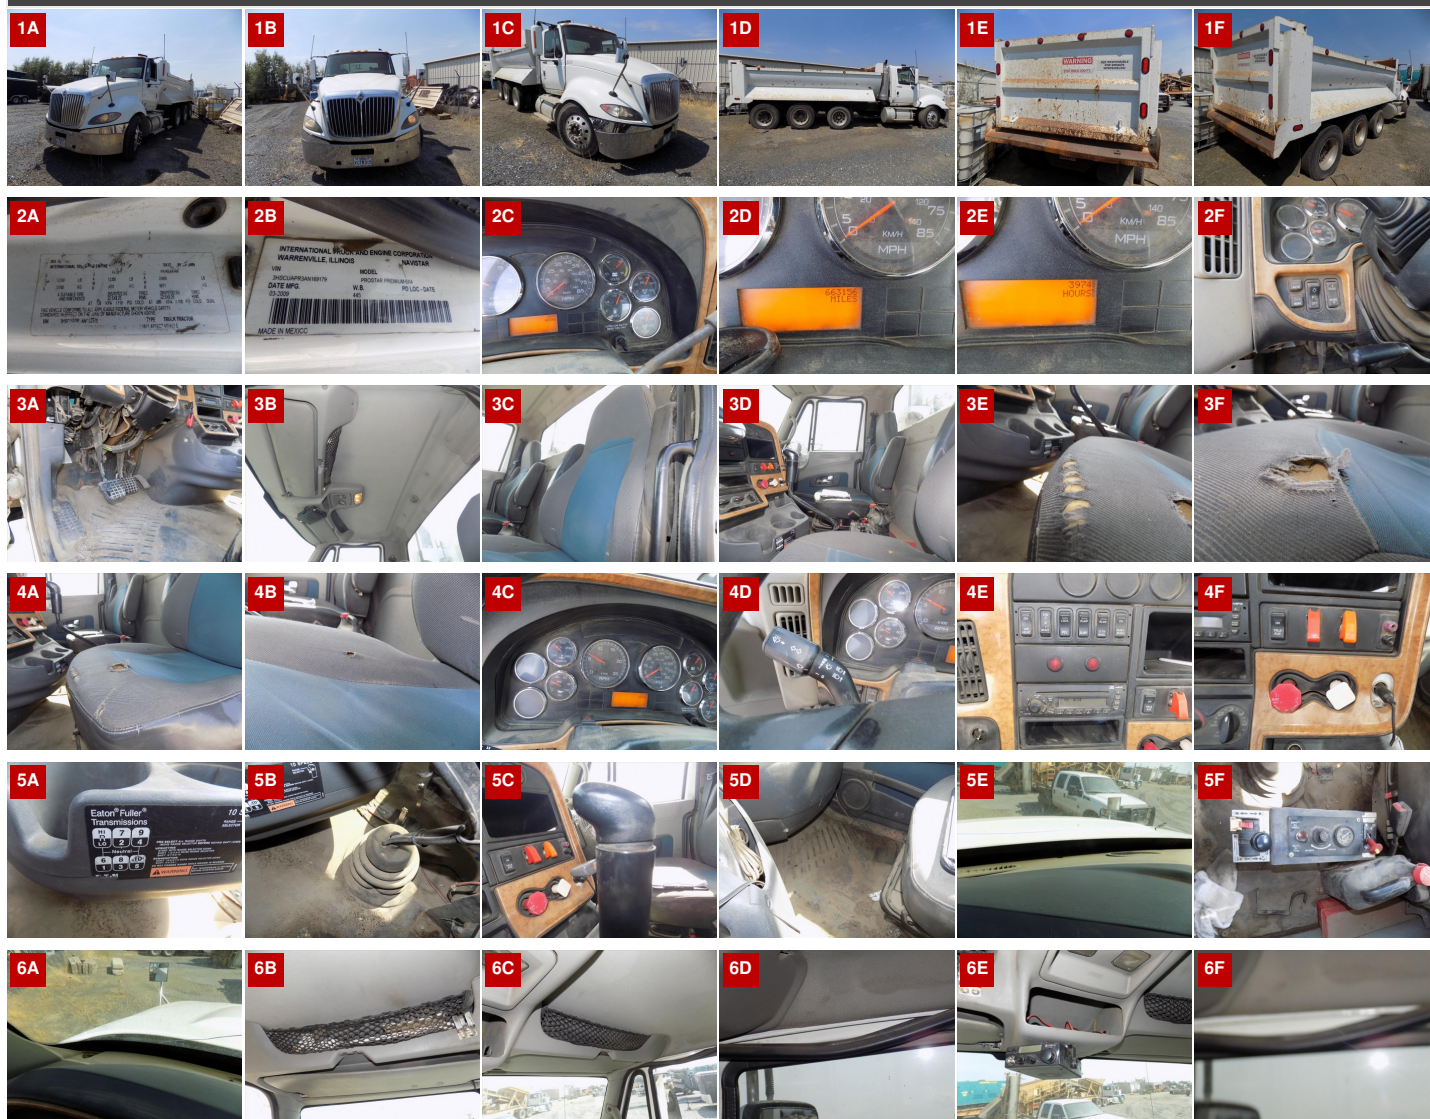
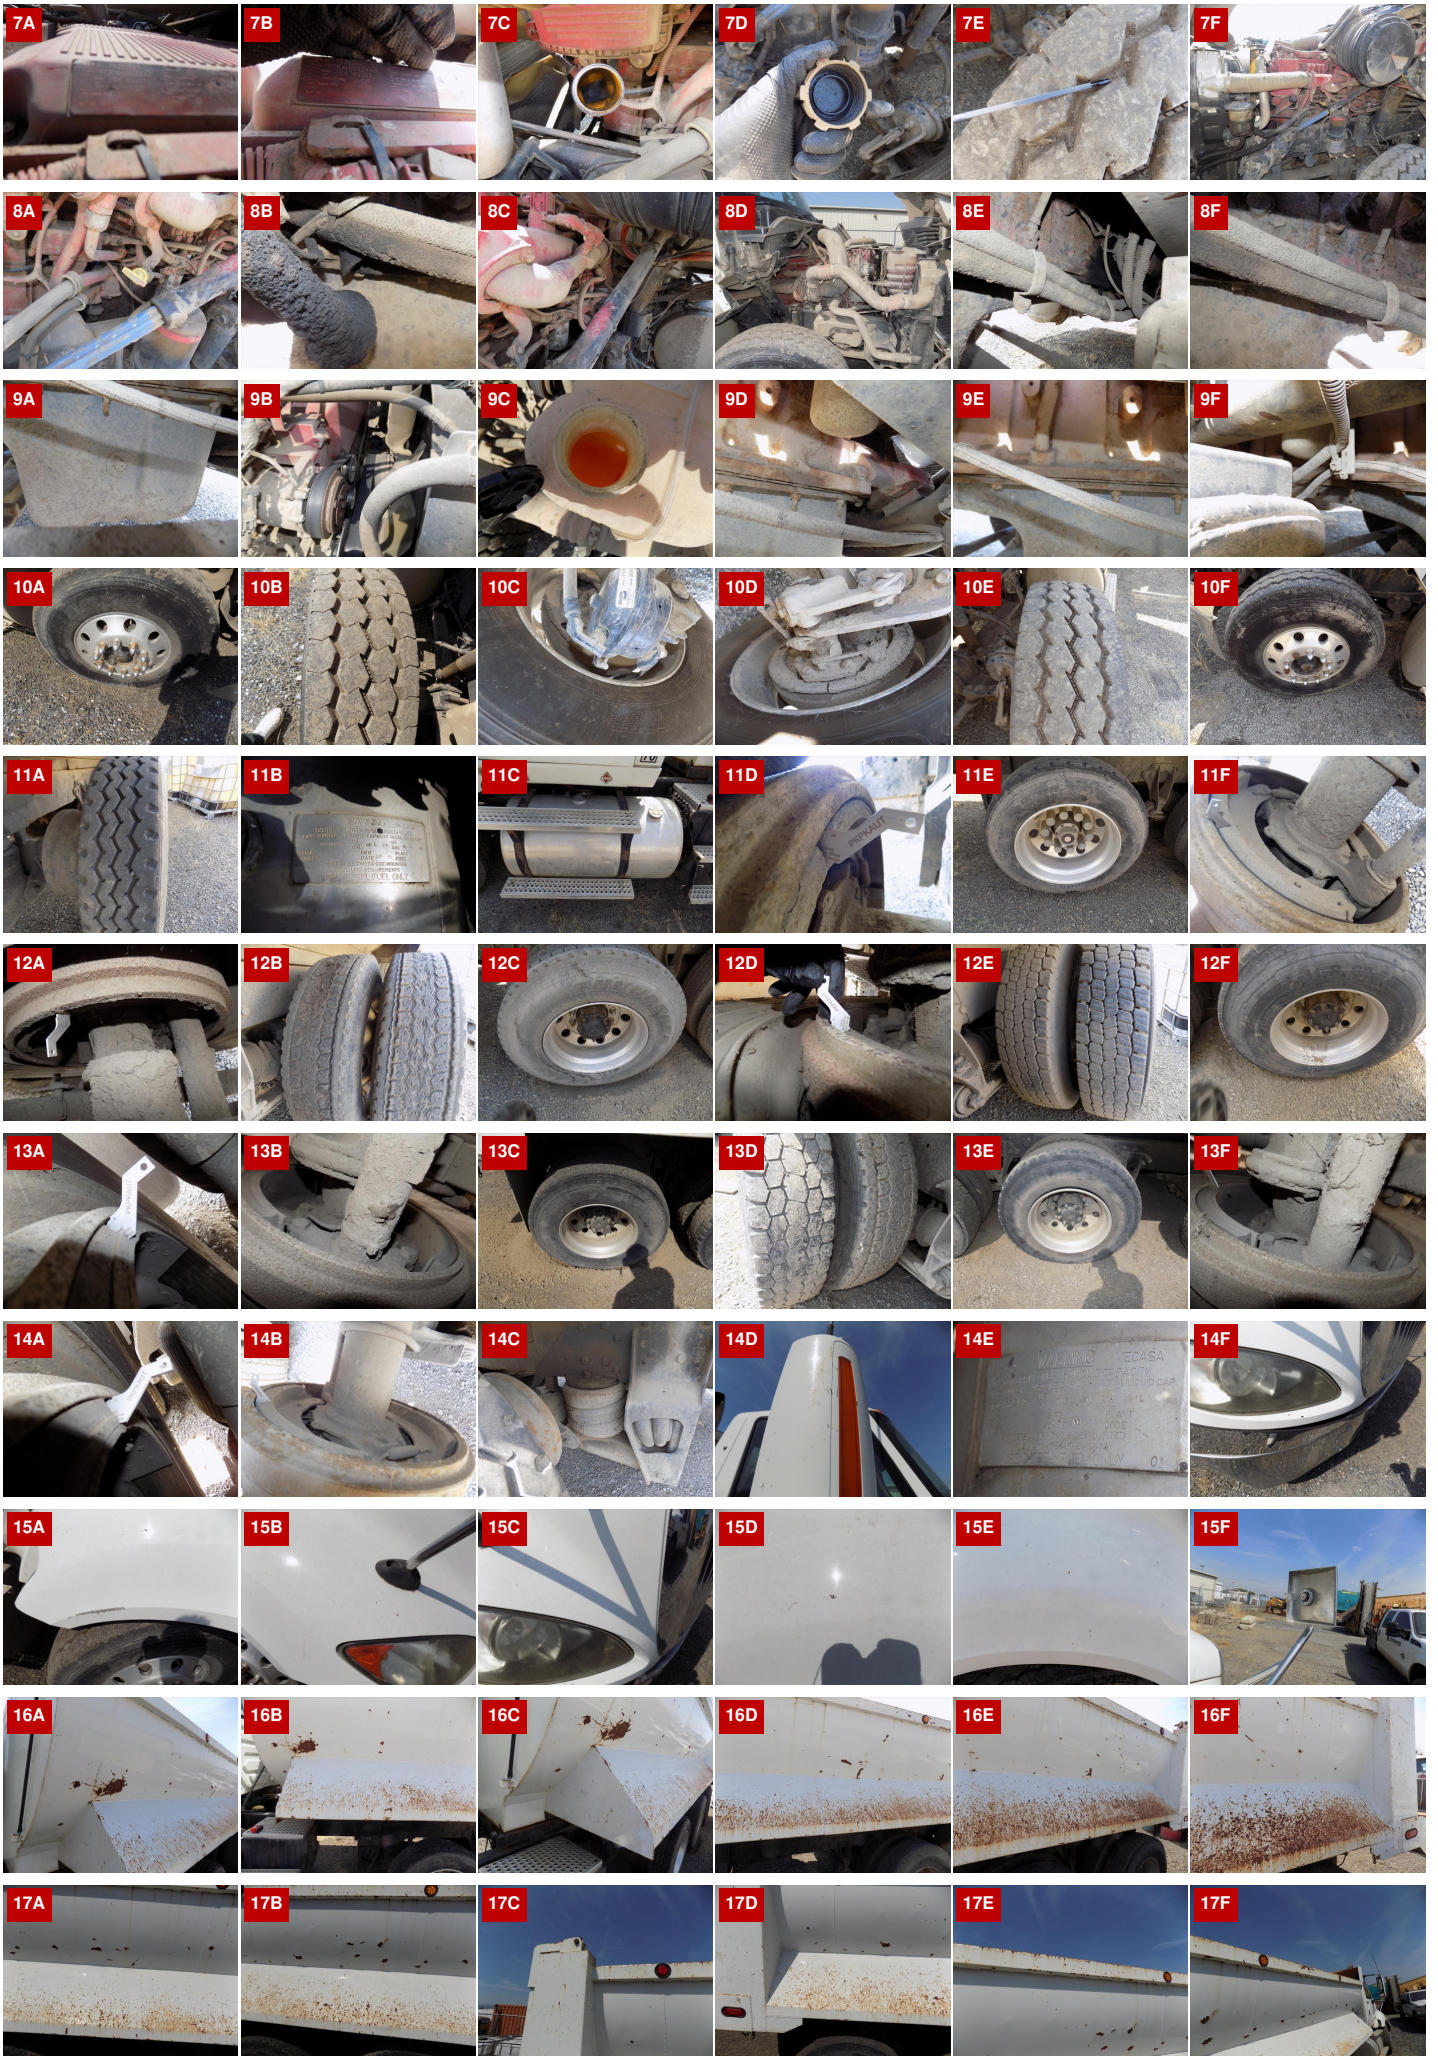
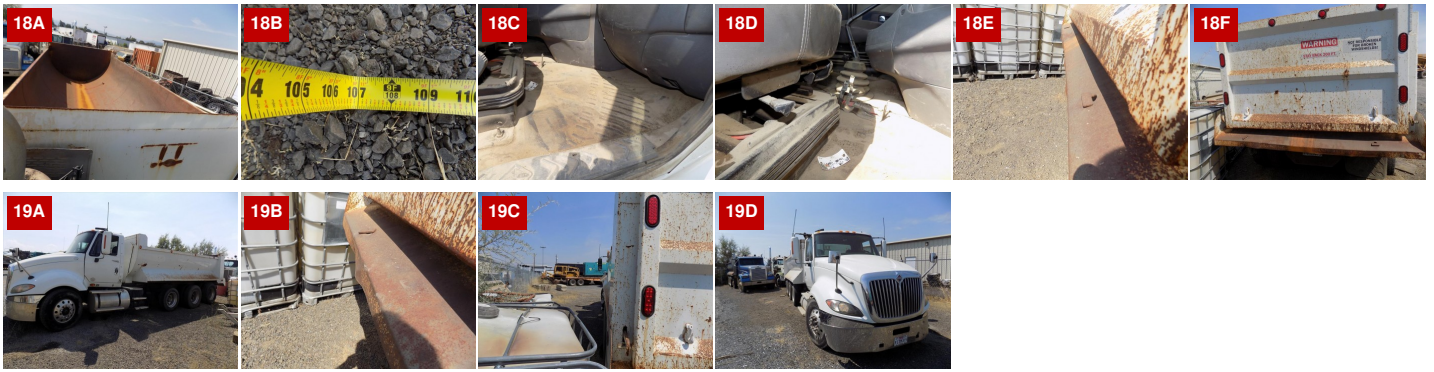
#### REPORT PHOTOS

CLUTCH PLATE/ SLIPPING/ COULD NOT GET VIDEO OF UNIT MOVING - SNAP TEST - OK. OIL LEAK AT D/S OIL PAN GASKET AREA. ODOMETER AND ECM MILEAGE DON'T MATCH. VIN INFORMATION ON ECM REPORT DOESN'T SHOW BUT HOURS ARE MATCH DASH
